NORFOLK ARCHAEOLOGICAL TRUST

ANNUAL REPORT

2015

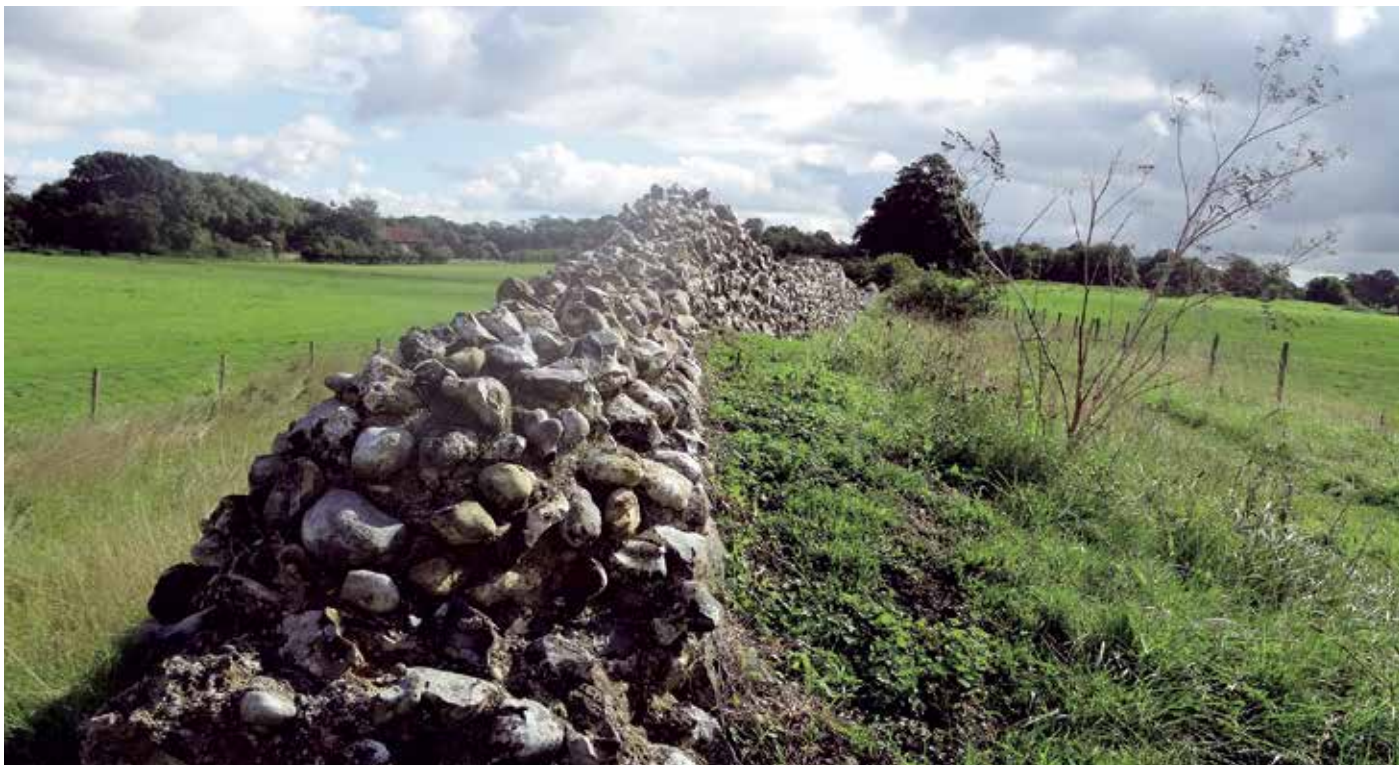
Image 6: Works to walls during 2015.

This summer has seen the final phase of conservation repairs to the walls of the town funded by Natural England. R&J Hogg completed consolidation of the last section of the north wall and will install a small area of soft capping in the autumn, employing the same technique as that used successfully at Castle Acre Priory last year. Research carried out by English Heritage has found that soft capping with turf can provide effective protection from thermal fluctuations and freeze-thaw action.

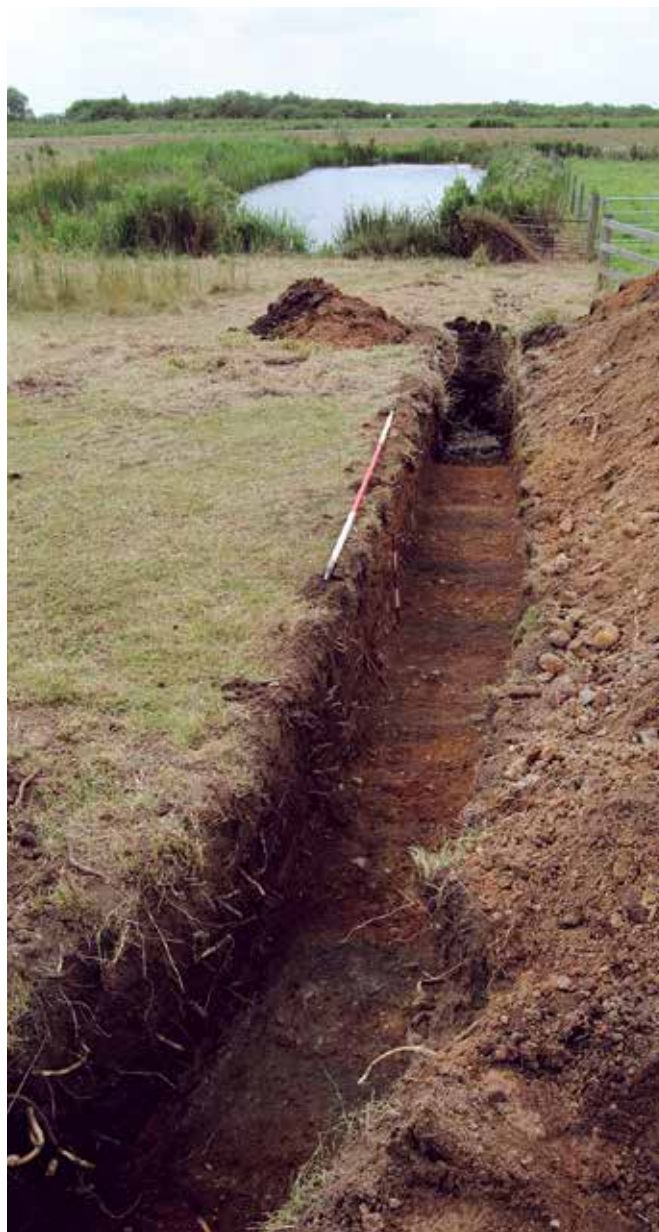
Image 8: Causeway deposits looking SW
Photo: Norvic Archaeology

The uppermost deposits of the causeway were exposed within the confines of the cable trench. Giles writes that 'at the surface at least, it was constructed and maintained not unlike a medieval roadway, with a large quantity of locally available sand and gravel used as consolidation material. The busiest phase of use, represented by worn out metalling and reconsolidation and repair, may be attributed to a medieval to early post-medieval phase, when the route still served as an important land route to the Abbey site, until its abandonment in 1545 with subsequent episodes of demolition and the quarrying away of its materials.'

He goes on to say that the recorded deposits suggest that during the post-medieval period, no further concerted efforts were made to import aggregate materials to maintain the integrity of this section of the causeway; and that by the late 18th to 19th centuries the western half of the causeway was certainly a cul-de-sac and may have served as a little used access route to the adjacent drained farmland and the late 19th century steam powered pump, which was sited at approximately the same location as the current electric pump house.

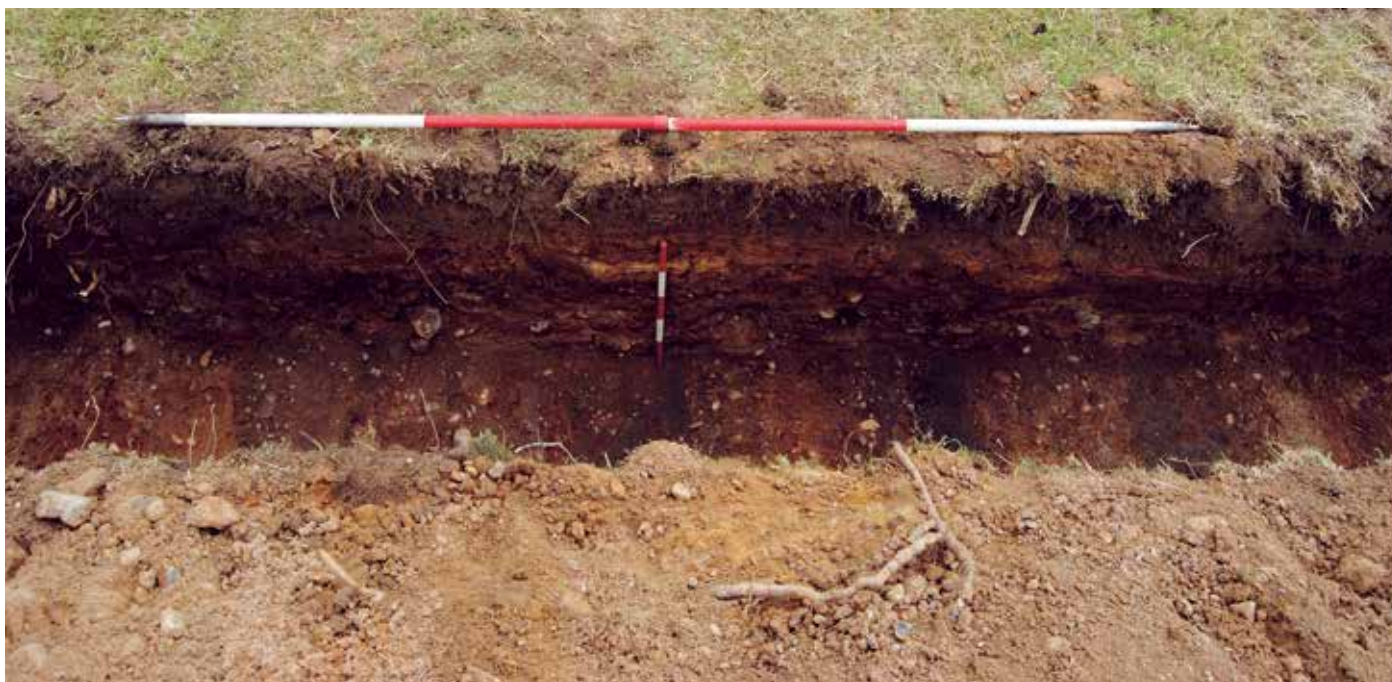
Image 9: Causeway deposits looking SE – wheel ruts visible Photo: Norvic Archaeology.

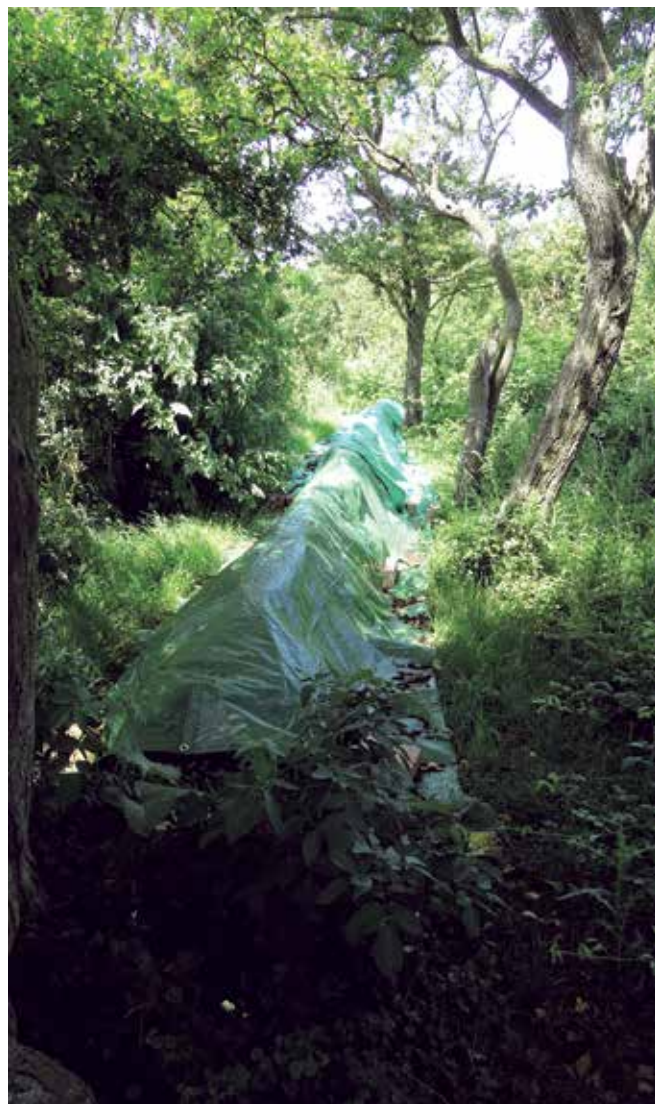
Image 10: St Benet's precinct wall during repairs showing overhanging shrubs.

As part of the Conservation, Access and Community project 2012 – 2014 consolidation works were completed to the precinct wall along the eastern boundary of the Abbey site by R & J Hogg. Unfortunately there have been some problems with these repairs due to a number of factors including the micro-climate created by the adjacent water-filled ditch, and overhanging bushes. In discussions with Historic England we have taken the opportunity during rectification to carry out a trial of different mortar mixes at the site: an NHL (Natural Hydraulic Lime) lime mortar for the capping masonry; a trial of 1:2 lime putty / aggregate with metastar 501 pozzalan; and a 1:3 hotlime mix.

Traditional lime putty is produced from the burning and slaking of calcareous/dolomitic stone. Mixed with sand the resultant mortar hardens or ‘goes off’ as a result of re-absorption of CO₂ from the air (carbonation). This is a slow process. ‘Pozzalan’ additives, such as ash and brick dust, enable lime mortars to set more rapidly. Hydraulic limes set in contact with water rather than air (although secondary hardening also takes place in contact with air). Mortars using NHL set more quickly and tend to be less vulnerable to mechanical frost damage. ‘Hot-lime’ mortars are prepared by adding specific measures of quicklime to aggregate and water, mixed together to form a mortar, usually on site. Hot-mixed lime mortars seem to have good frost resistance although the reasons for this are not fully understood. The repaired wall has been protected with rigid corrugated iron supported clear from the wall top, to be left in place over winter. The results of the trials will be available in spring 2016.

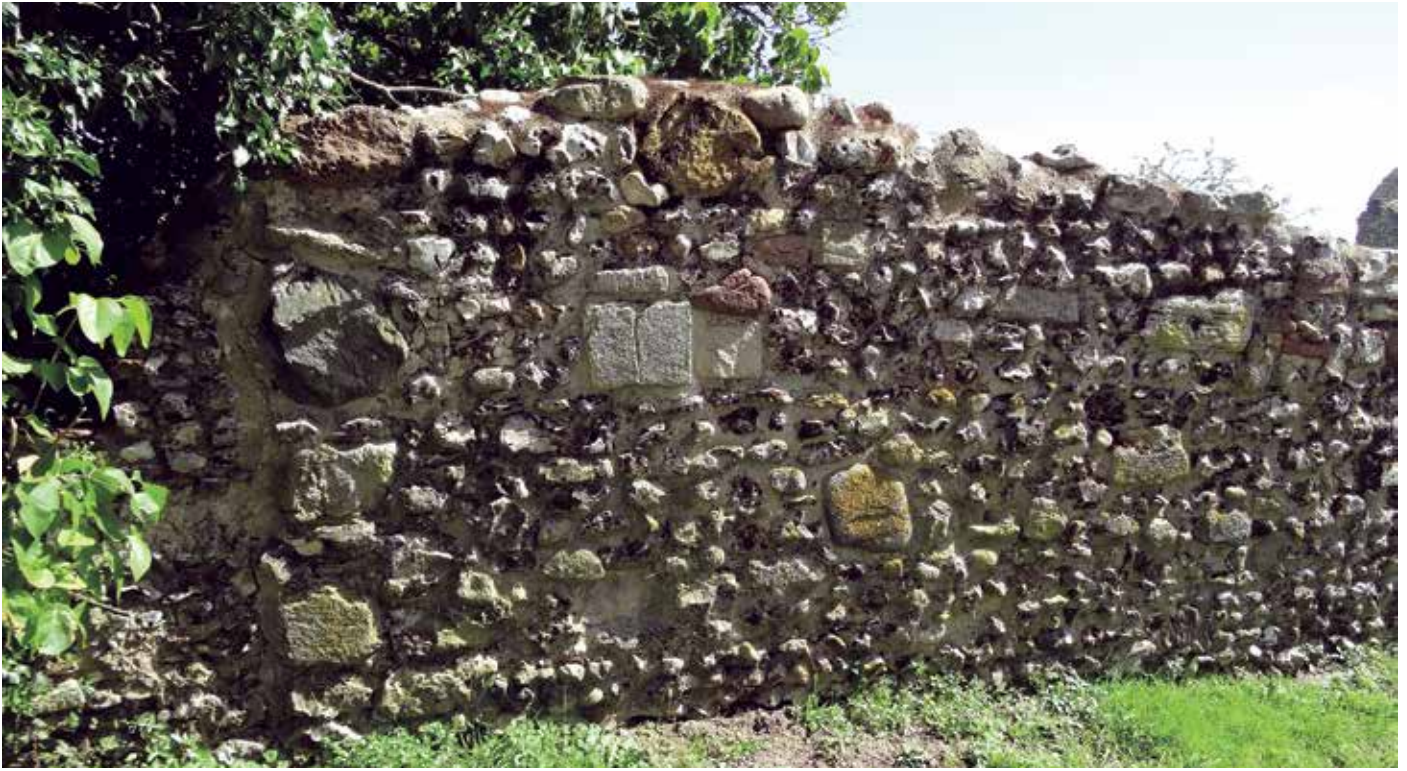
Image 12: The western boundary wall at Burnham Norton Friary

During the survey the bryologist and geologist Robin Stevenson was immediately struck by the variety of exotic lithologies present in the precinct wall adjacent to Friar's Lane, including igneous granites and basalts, metamorphic schist, and several exotic sandstones.

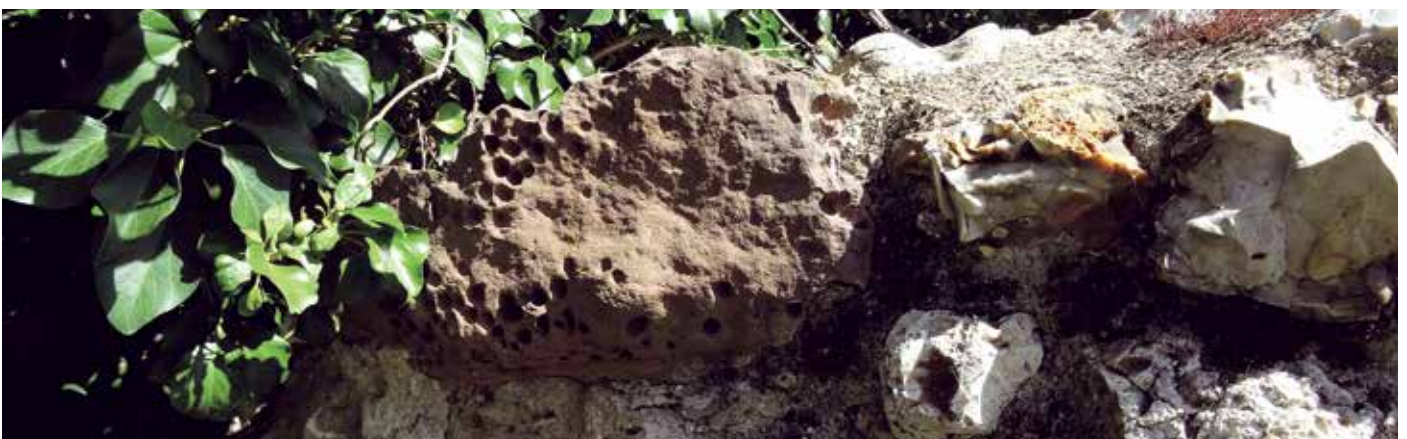
Image 13: Clast with with bivalve borings

In an interesting note on the wall he writes that the size and rounded shapes of these examples are such as to preclude an origin from local glacial deposits and that a much more likely origin was as ballast material, brought in by ships visiting nearby harbours.

He goes on to say 'The most convincing evidence for a ballast origin lies with the figured clast, which shows clear signs of marine bivalve borings. This must have been obtained from a coastal marine location, and nothing similar occurs on the Norfolk coast, suggesting strongly an exotic origin. Boulders such as this would have been much favoured as ballast material being obtainable near at hand, at source, and having a commercial value at the point of arrival, when they would be replaced by a load destined for export.'
